ANNUAL REPORT FOR 2015

Bailey Branch Site D Mitigation Site
Madison County
TIP No. R-2518A
COE Action ID: SAW-2007-2197-357/300
DWR #: 20071134

Prepared By:
Natural Environment Section & Roadside Environmental Unit
North Carolina Department of Transportation
November 2015

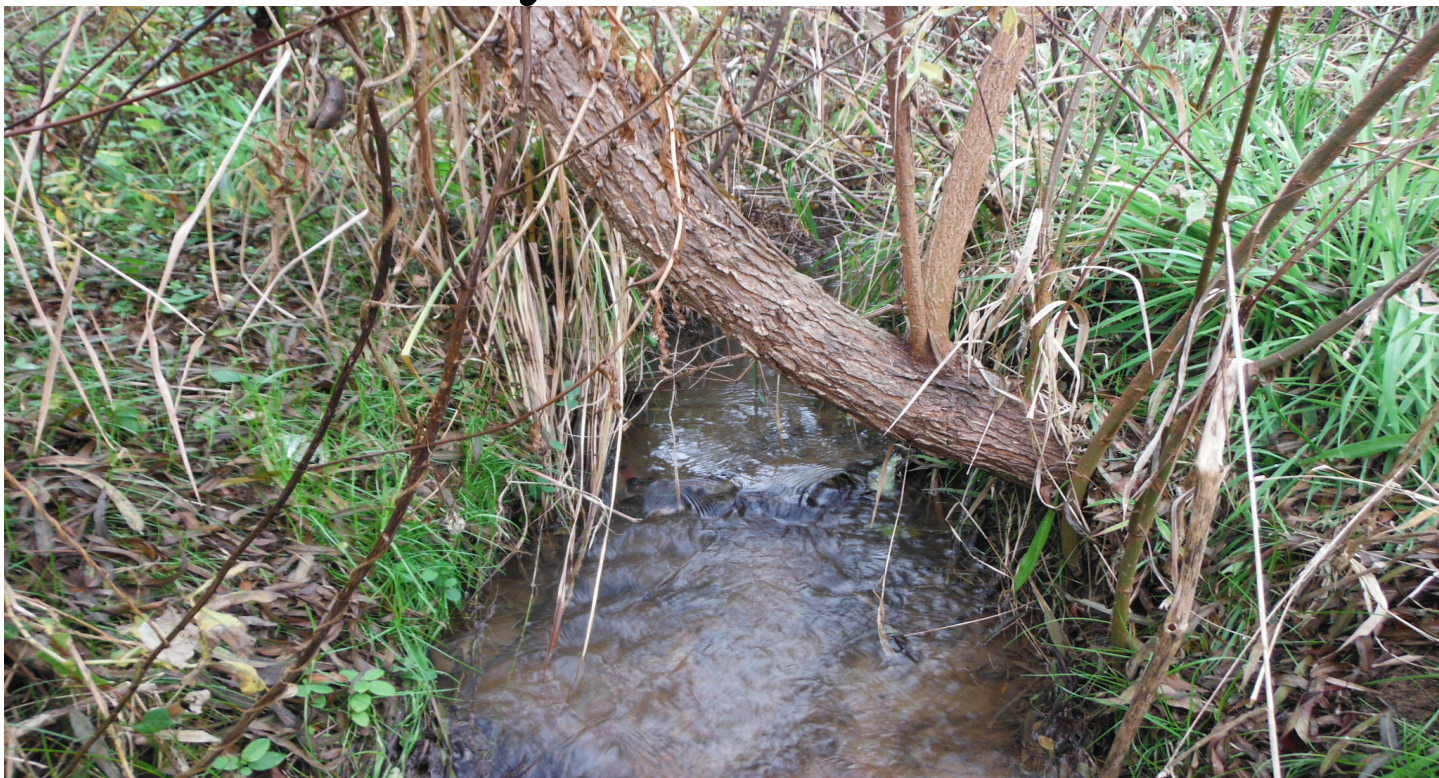
Bailey Branch Site D

Site D was visually inspected and photographed for channel stability and planted vegetation survival. Based on the 2015 visual inspection of the stream, the channel and its streambanks are stable at this time. Four bankfull events were documented by a surface water gauge at Site D for the 2013 and 2014 monitoring years.
